### HISTORIC SITE SUMMARY SHEET

Survey #:I	2.G. #71B-2-26		Building	g Date:	<u>ca. 1</u>	900
Building Name:	House					
Location:	12819 10th Str	eet (south	side), E	Bowie, M	Maryland	
	Private/Resi	dence/Occu	nied/Fair	r/Inacce	essible

## Maryland Historical Trust State Historic Sites Inventory Form

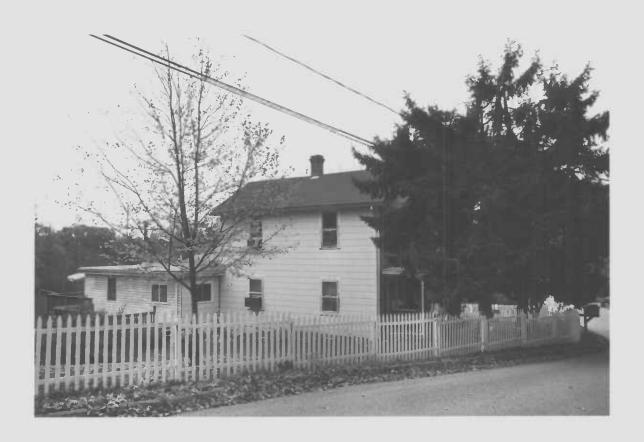
R=71B-2 26

House
12819 10th Street, Boxell
Prince George's Co., MD
Ausan H. Class
Morember 1971
Northeast 34 sleetation
